[Docket No. 97-CE-35-AD; Amendment 39-10070; AD 97-12-06]

Airworthiness Directives; Cessna Aircraft Company Model 172R Airplanes

### **97-12-06 CESSNA AIRCRAFT COMPANY:** Amendment 39-10070; Docket No. 97-CE-35-AD.

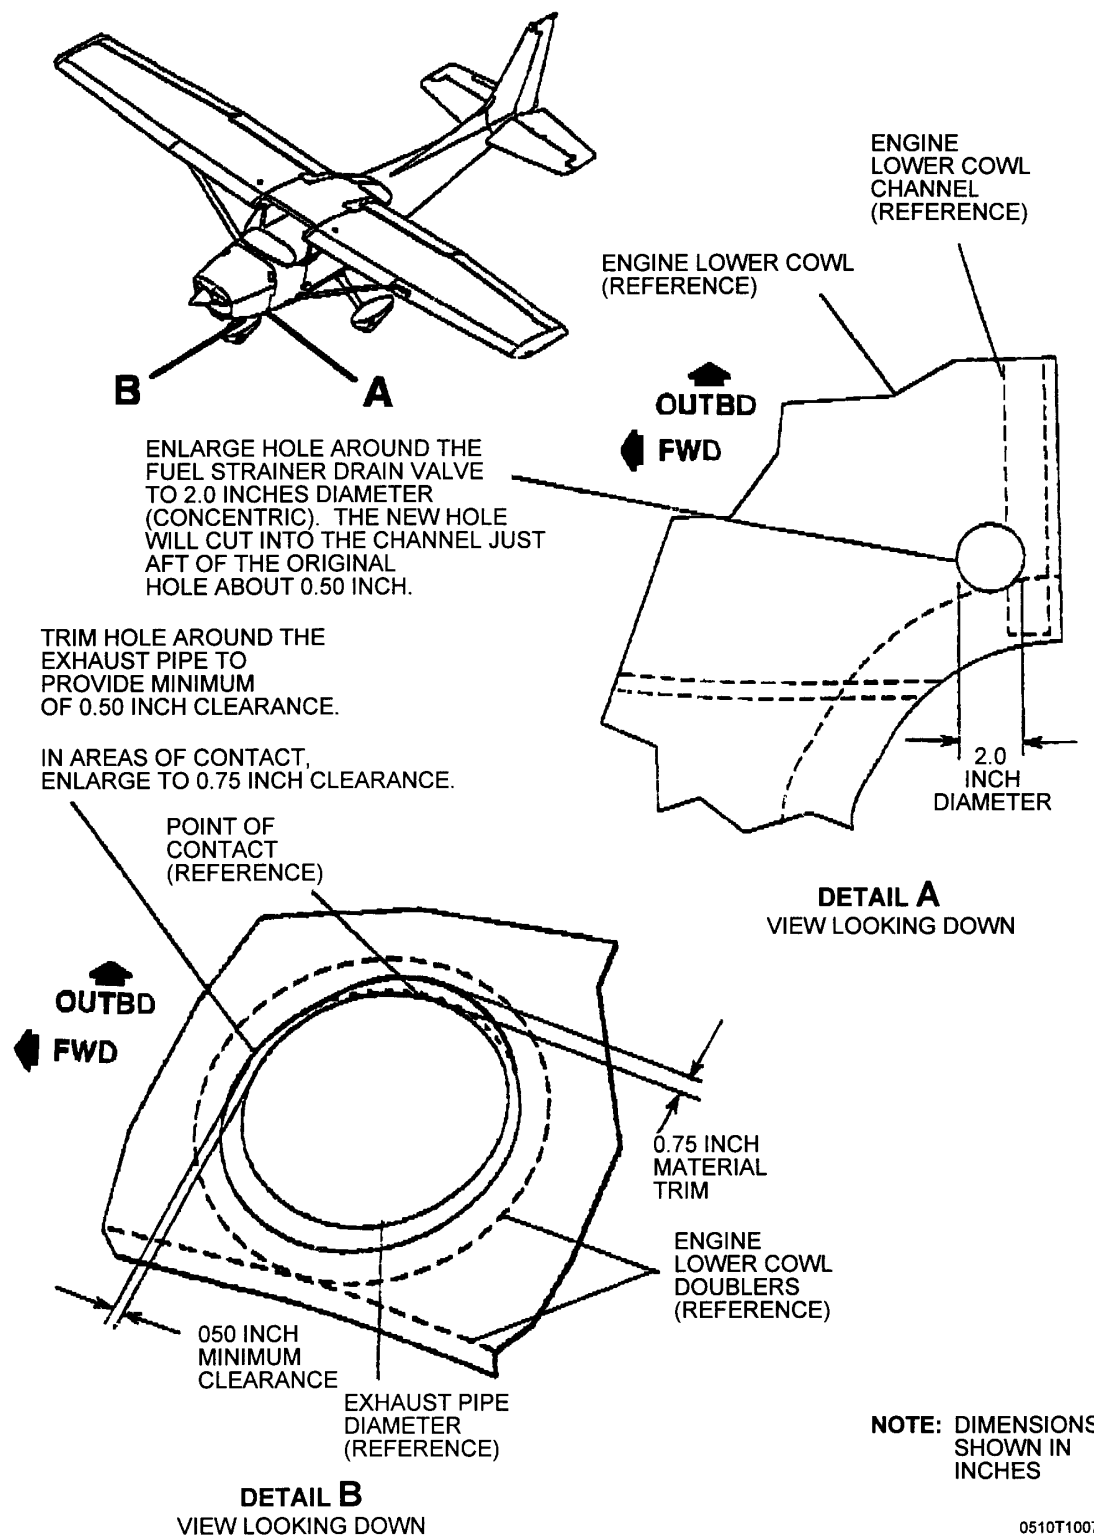
Engine Lower Cowling Modification  
Figure 1

On June 6, 1997, the FAA issued priority letter AD 97-12-06, which applies to certain Cessna Model 172R airplanes. That AD resulted from an occurrence of fuel loss on one of these airplanes, which was severe enough to force an emergency landing. Investigation of the occurrence revealed that the cowling knocked the gascolator drain valve off the gascolator.

Further examination of the design of the Model 172R airplanes shows that this condition exists when the tailpipe vibrates, during some starting conditions, into the cowling. The cowling then rubs against the gascolator drain valve, knocking the gascolator drain valve off the gascolator, and causing fuel to drain from the airplane at an extremely high flow rate. This results in engine stoppage with consequent forced landing or crash landing.

(2) If no evidence of rubbing is found, repeat the check in paragraph (a) before each flight, and within the next 10 hours time-in-service (TIS) after the effective date of this AD, modify the gascolator and cowling area in accordance with Figure 1 of this AD.
